batt + lear
designers and builders

WHAT ARE WE GOING TO DO WITH THIS HOUSE?

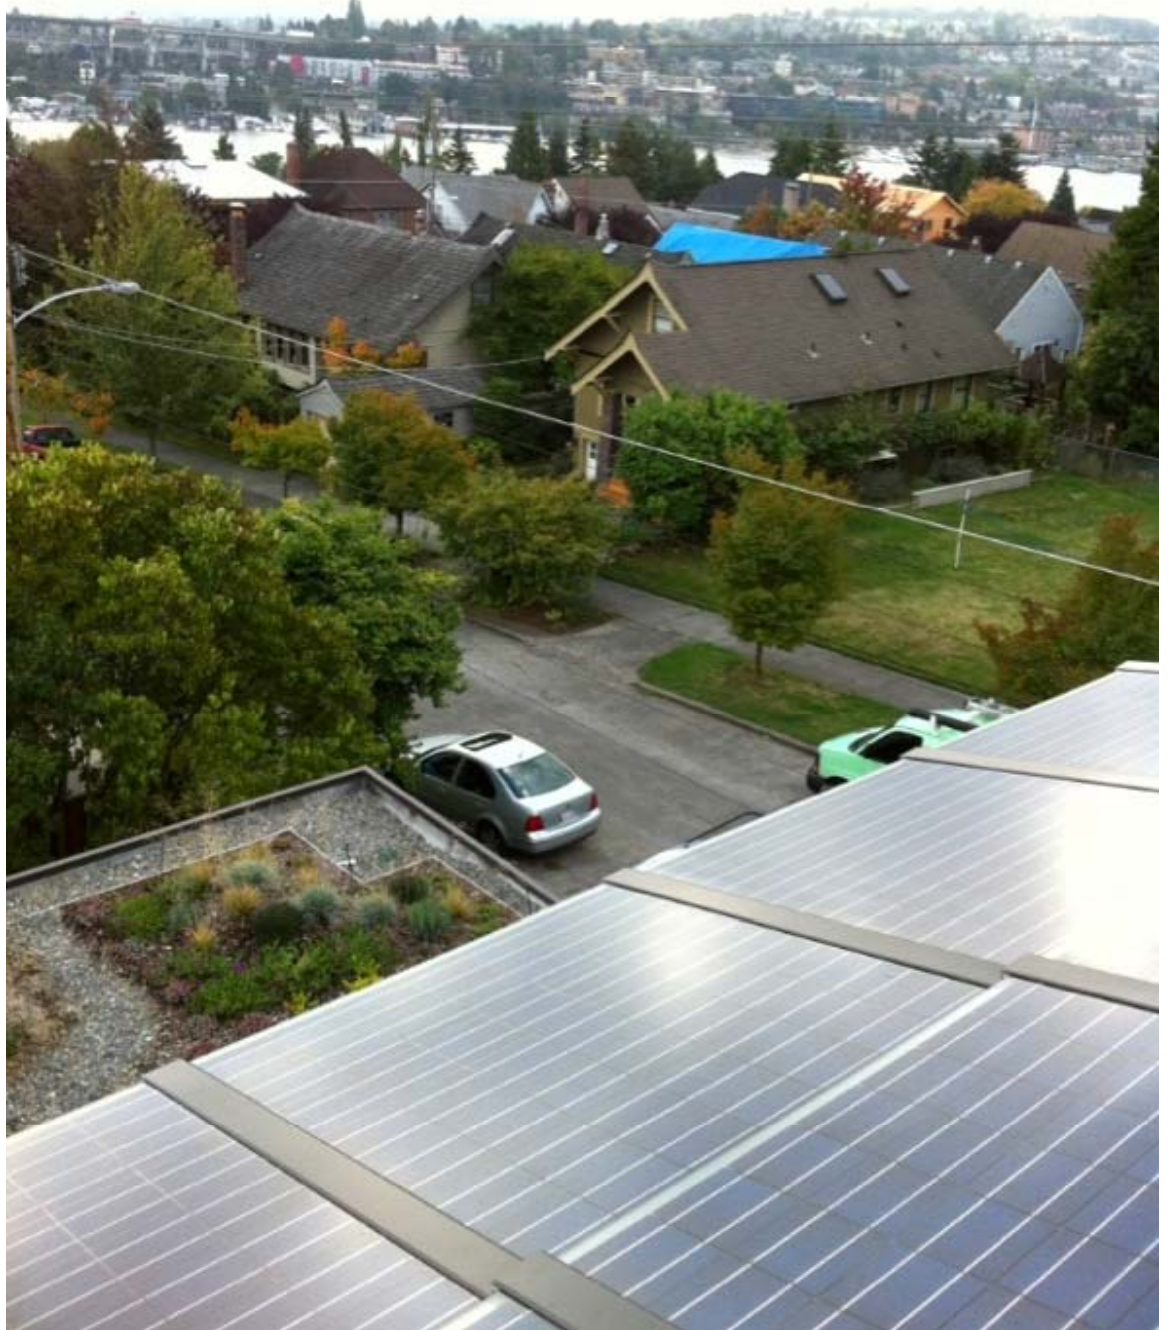
High performance envelope

- 1.25" continuous rigid foam w/ dense-pack cellulose in walls
- Raised heel trusses
- R-60 attic insulation
- ICF basement walls
- Advanced framing
- Ventilated spray foam beneath green roof
- Continuous drywall & no can lights at top floor ceiling for superior air barrier
- Advanced Glazing (Serious and Fibertec)
- Integrated Home Performance testing
- Right-sized heat pump heating system, with integrated fresh air intake system
